Evaluation of Radon Sources and Phosphate Slag in Butte, Montana

Montana State Dept. of Health and Environmental Sciences, Helena

Environmental Protection Agency, Washington, DC

EPA 520/6-83-026
June 1983

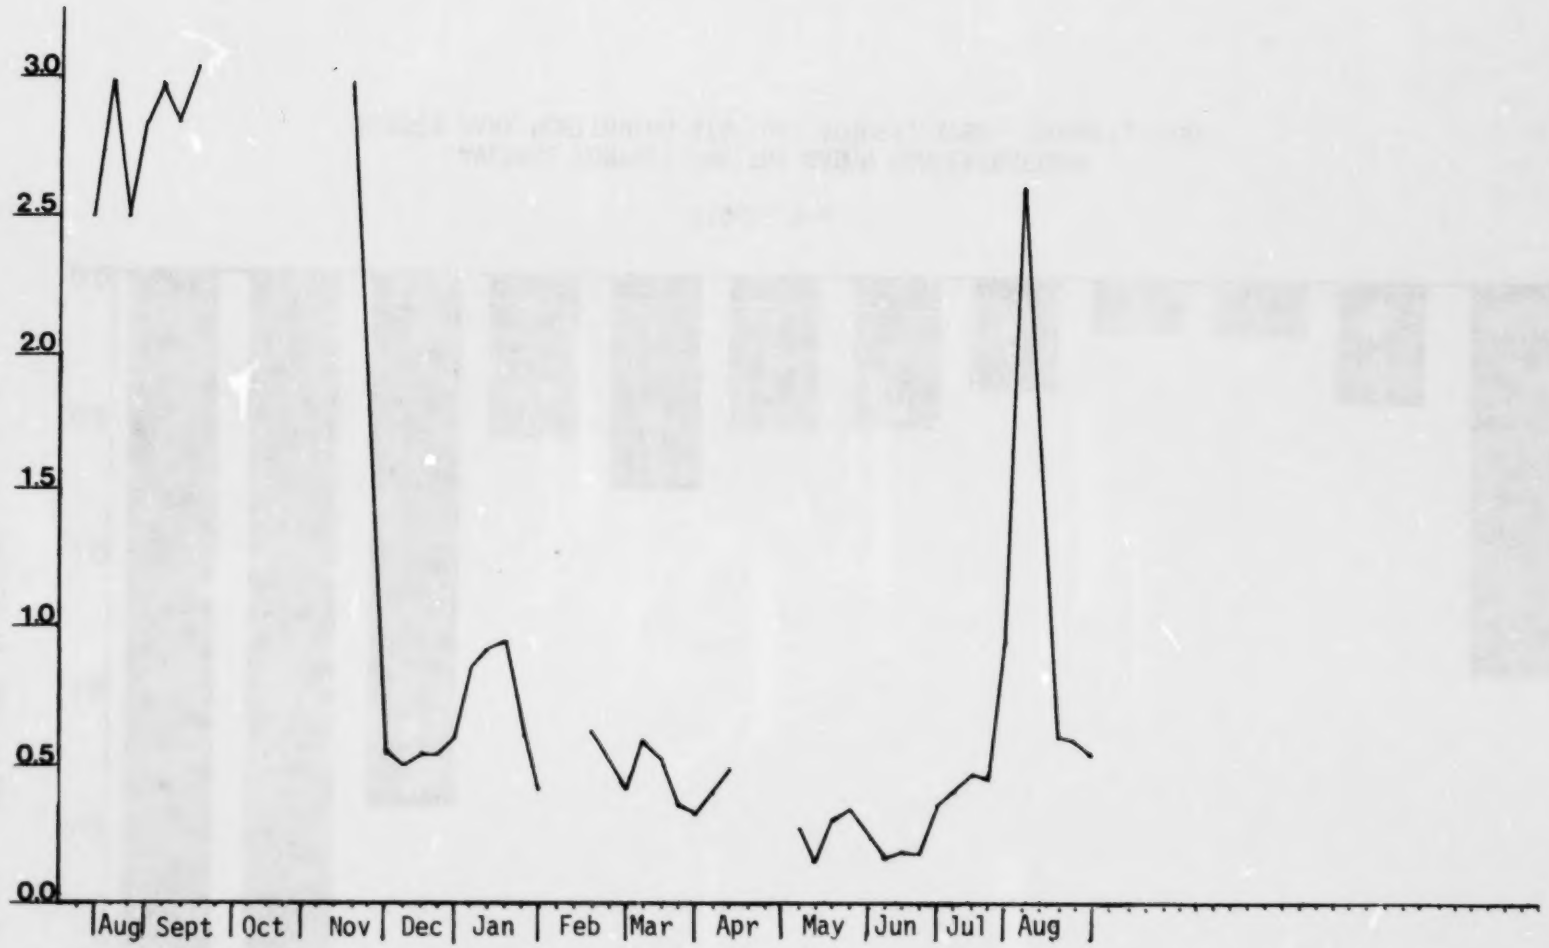
FIGURE 5-7

Figure 5-7 shows ambient radon concentrations averaged weekly and Figure 5-8 shows average monthly ambient radon concentrations at the Hebgen Park Monitoring Station for the period August, 1980 through August, 1981. It is interesting to note that average ambient radon concentrations ranged from a high of about 3 pCi/l to a low of less than 0.25 pCi/l. The highest concentrations were observed between August and November. Concentrations diminished through the winter months and reached a low in May and June.

Measurements of soil moisture were not made, but it is believed that the soil moisture content is probably responsible for the differing ambient radon concentations seen in Figures 5-7 and 5-8. In the winter months, the soil in the Butte area freezes to a depth of several feet. DHES believes that the frozen soil produces a capping effect that inhibits radon exhalation. Radon soil gas measurements made in the alluvium at a depth of 30 inches showed a radon soil gas concentration in winter months 69 percent higher than in summer months.

AVERAGE WEEKLY AMBIENT RADON CONCENTRATIONS
HEBGEN PARK MONITORING STATION, AUGUST, 1980 - AUGUST, 1981

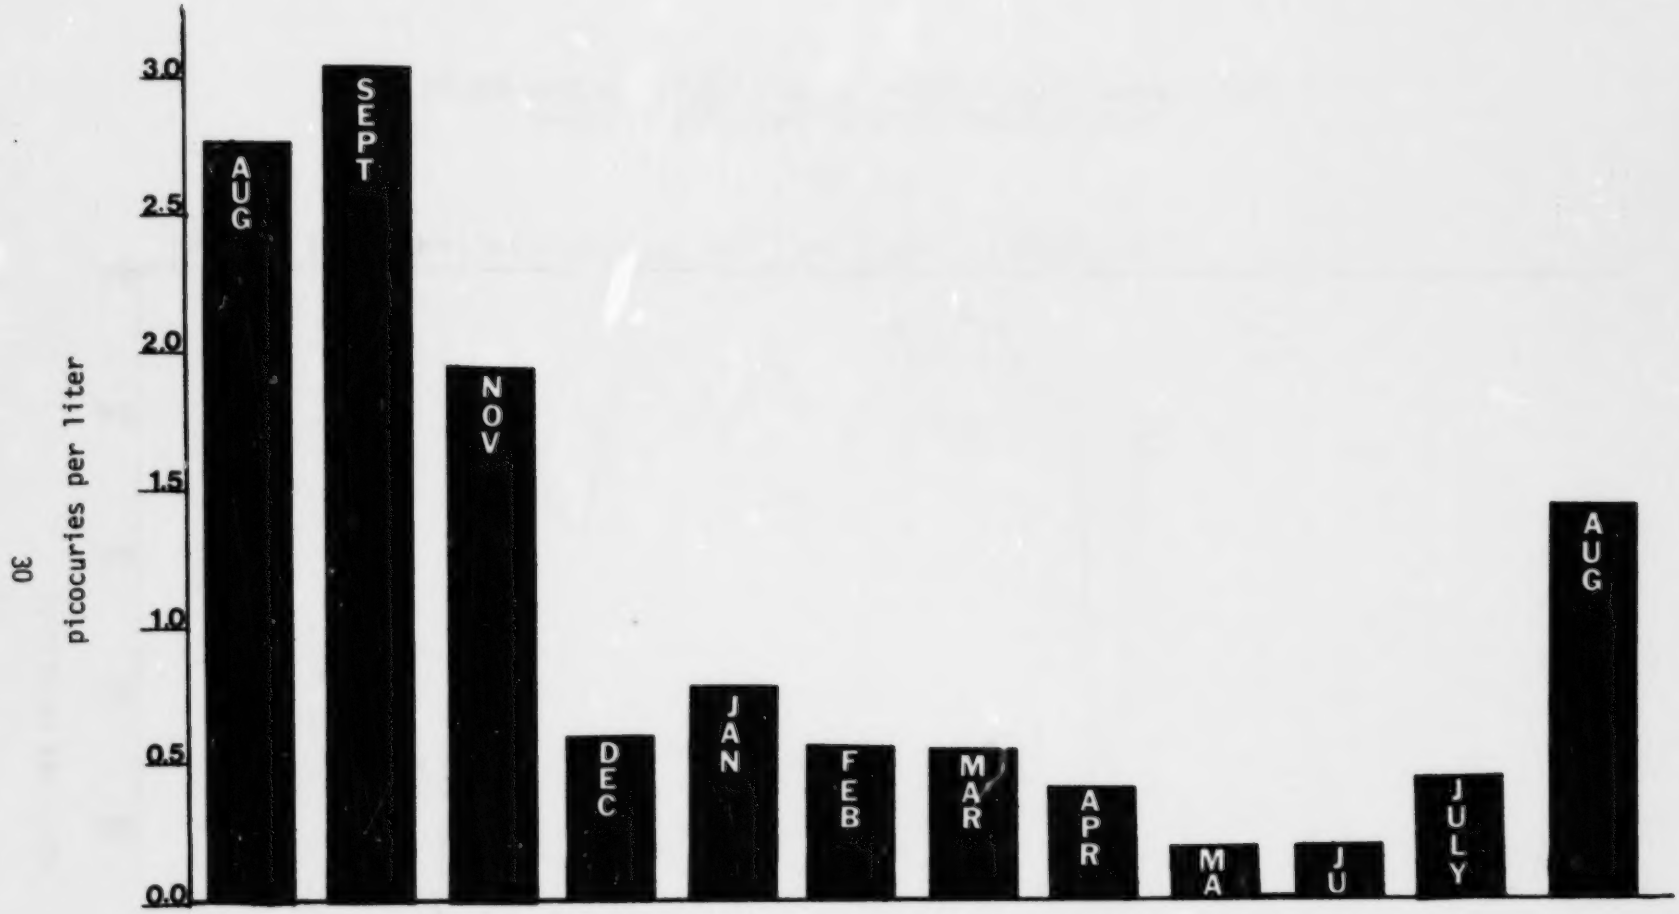
FIGURE 5-8

The spring of 1981 was unusually wet in western Montana. Precipitation in Butte during the months of April, May and June totaled 7.62 inches. The ambient radon concentrations for May and June, when the soil was heavy with water, were the lowest of the year. These measurements also indicate that an inverse relationship most likely exists between soil moisture content and the soil radon flux.

AVERAGE MONTHLY AMBIENT RADON CONCENTRATIONS
HEBGEN PARK MONITORING STATION, AUGUST, 1980 - AUGUST, 1981

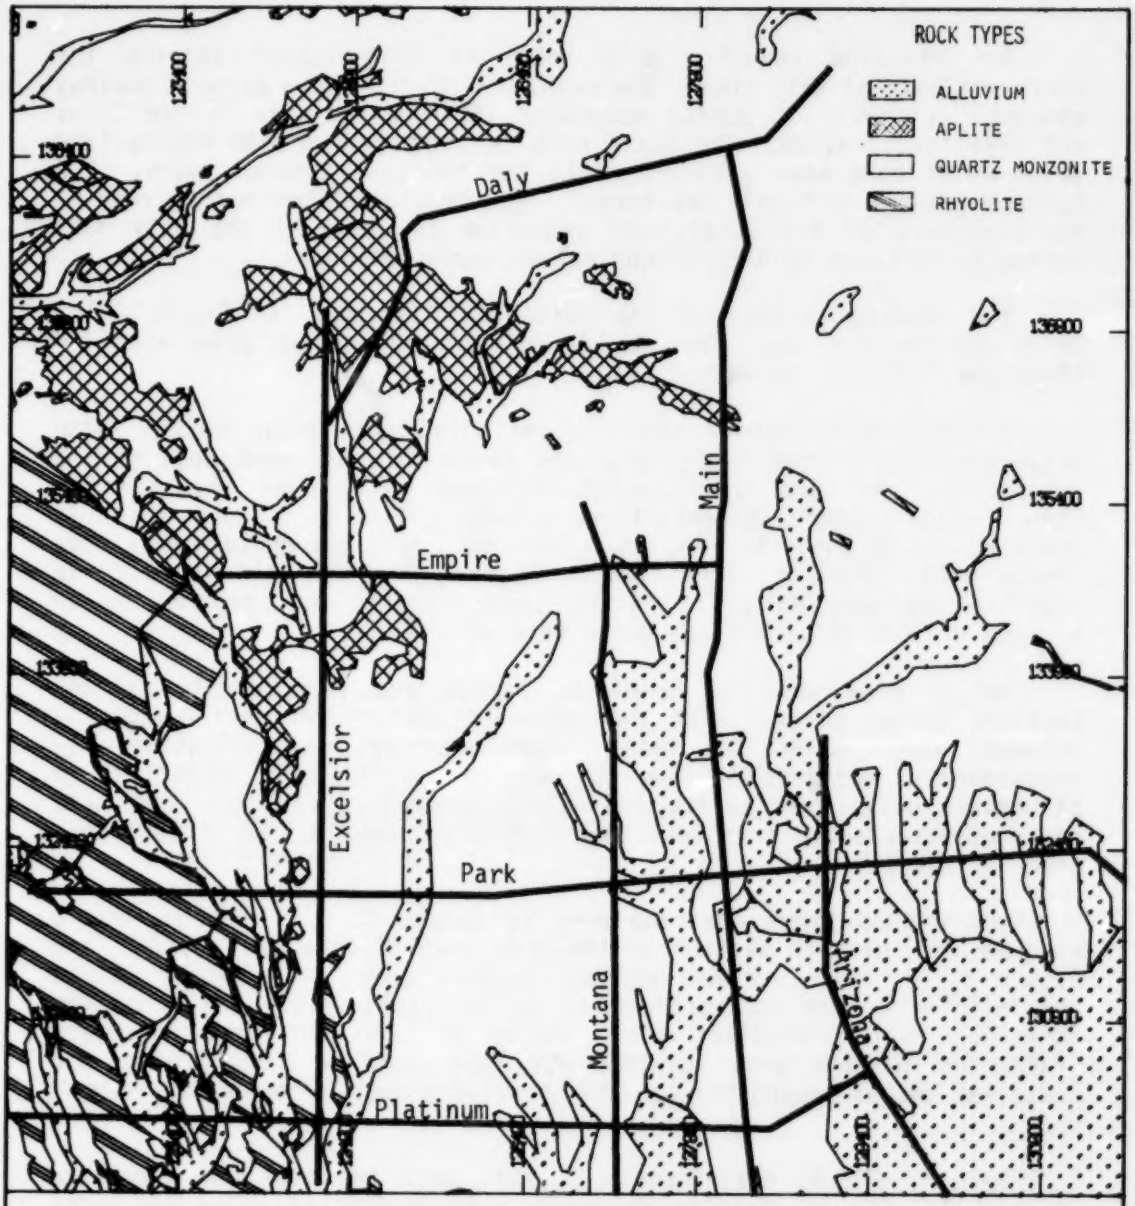
FIGURE 5-12

The surface geology of the Butte hill is shown in Figure 5-12. Veins and fractures are shown in Figure 5-13. Veins are shown as solid lines and fractures by dashed lines.

NORTHWEST BUTTE SURFACE GEOLOGY

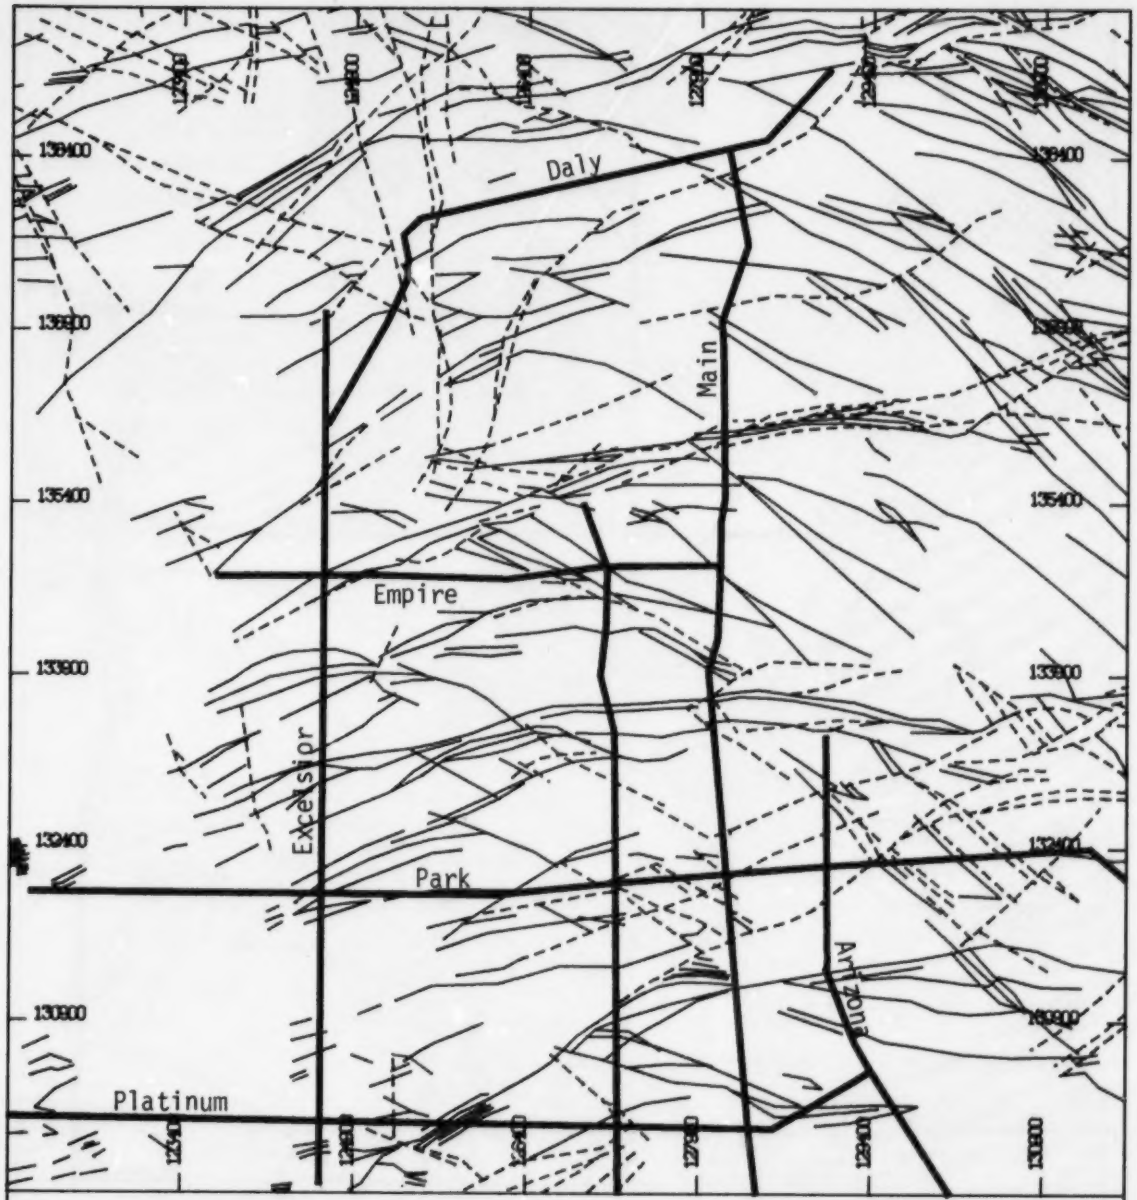
FIGURE 5-13

VEINS AND FRACTURES IN
NORTHWEST BUTTE GEOLOGY

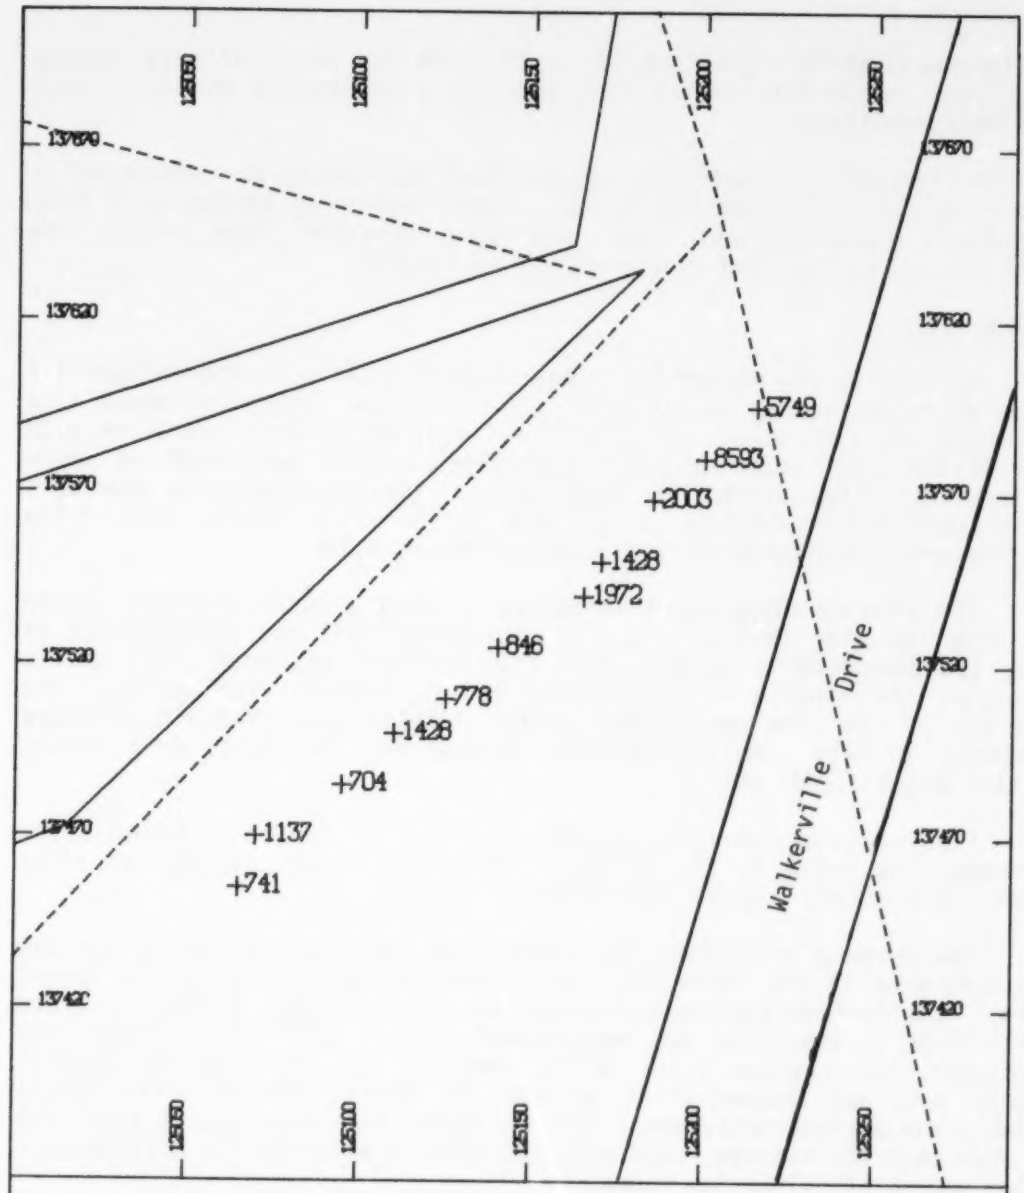
FIGURE 5-25

The line of alpha-track detectors crossed a major fracture (shown as a dotted line in Figure 5-25). The radon soil gas measurements at the two measurement points near the fracture averaged 7171 pCi/l; whereas, the other nine measurement points averaged 1226 pCi/l. The average of the nine measurement points located away from the fracture compares closely with the overall average for the Butte area during winter months (1407 pCi/l).

Fractures in underlying geology are believed to act as conduits for transporting radon to the surface. The measurements at the two sites near the fracture support this theory.

RADON SOIL GAS CONCENTRATIONS (pCi/l)
IN APLITE - WALKERVILLE
